# 2007 BAR BC PROJECT COMPLETION REPORT

STARTED JULY 25 2007 ENDED NOVEMBER 1 2007

The Bar BC 2007 project consisted of four buildings, HS-1366 Main Cabin, HS-1377 Office Cabin, HS- 1382 Dude Cabin and HS-1386 Carncross Cabin. Three of the buildings 1366, 1377, and 1382 underwent stabilization work and 1386 received the beginnings of a complete restoration.

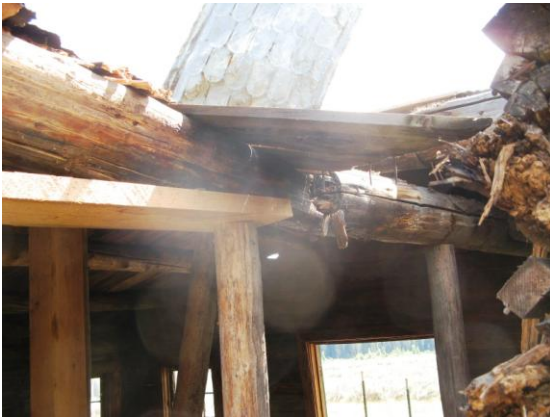
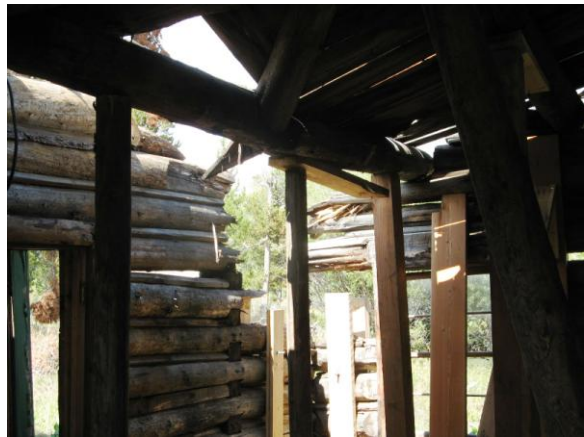
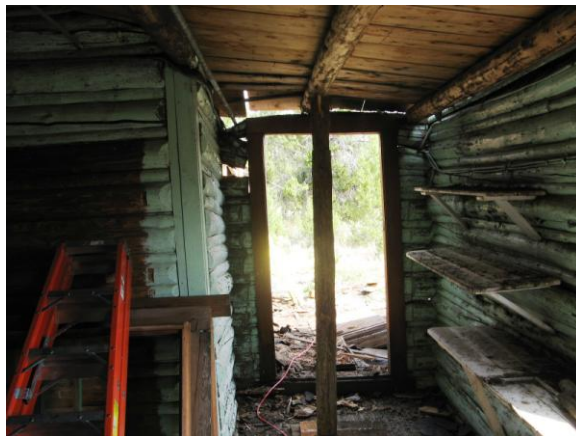
**HS-1366 Interior roof support**

The interior roof support was confined to areas of deterioration that compromised the integrity of the roof such as rotted eve logs and purlins. This was done not only for support of the roof tarp system but also to provide safe access onto and on the roof for human activity.

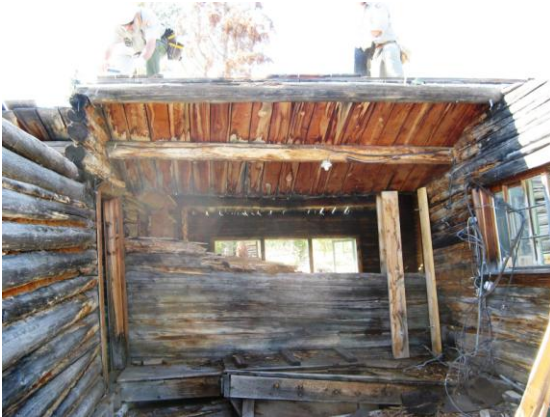
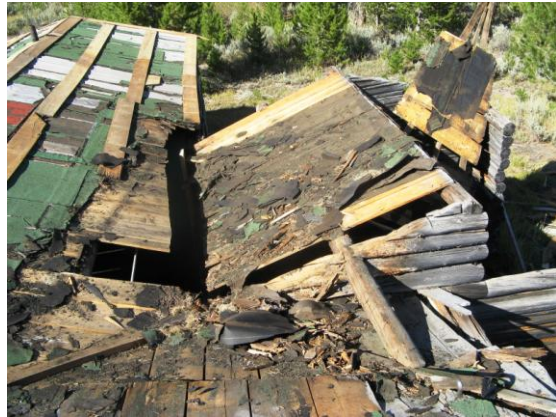
**HS-1366 partial addition removal**

After the fire in the Main Cabin in 1936 the building underwent a reconfiguration with the building of several additions to the main structure. One of these only partially remained and was causing further deterioration of the structure by supporting a non-working valley drain, causing severe strain on the main structure as the addition processed through its collapse and also provided an unsafe working environment. It was determined since it was not part of the original structure and because of its detrimental effect on the portion of the main structure where attached that it should be removed as part of the stabilization process. Attached floor plan shows area removed.

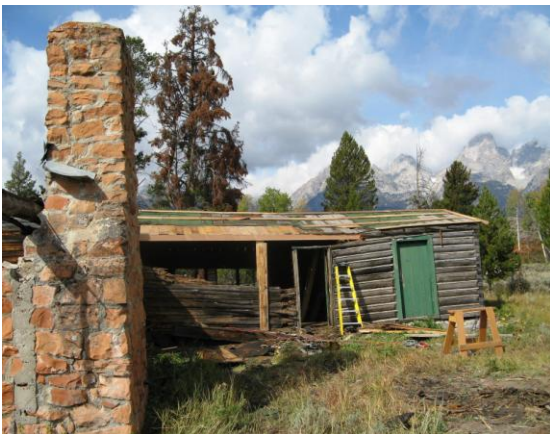
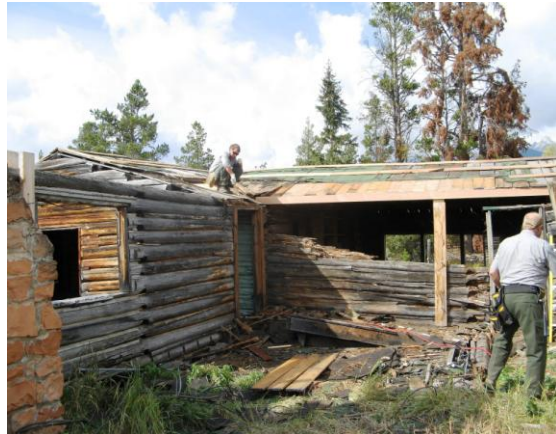
**HS-1366 after removal**

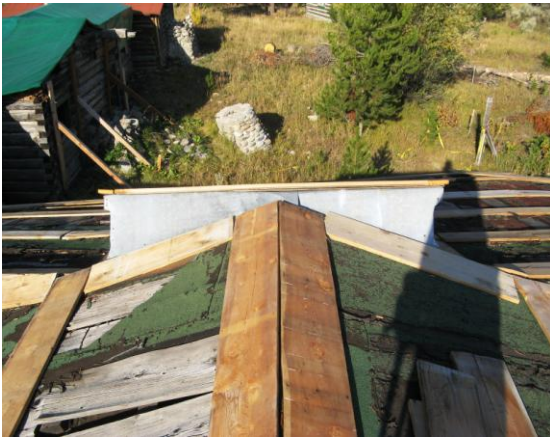
**HS-1366 notice tarp on roof in upper left**

To help maintain the Main Cabin's remaining structural integrity it was deemed necessary to protect the buildings interior by covering the roof. Heavy duty poly ultraviolet resistant tarps were used for this purpose. Labor and material costs were considered and the tarp system chosen over other methods as a temporary protective preservation method. The roof was strip sheeted with 1 X material salvaged from the disassembled hay sheds located at the historic Aspen Ridge Ranch in GRTE. These consisted of varying lengths and widths. They were used to provide a solid fastening point using wind screws to attach the tarps to the roof. The spacing between the boards varied according to need but did not exceed 24 inches. Horizontal runs were made along all slopes and also all ridges, gable edges and eve edges were strip sheeted. Where the tarps tucked back under the eaves they were also used if a solid fastening material was not available. Once the roof was strip sheeted the tarps were stretched over the roof and fastened to the stripping boards with wind screws.

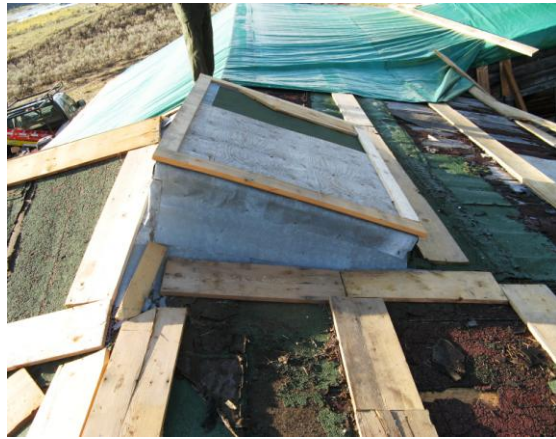
**HS-1366 stripping and tarp cover**

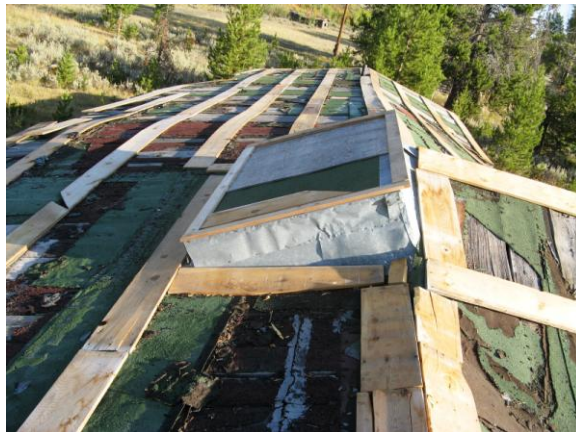
**HS-1366 stripping for tarps**

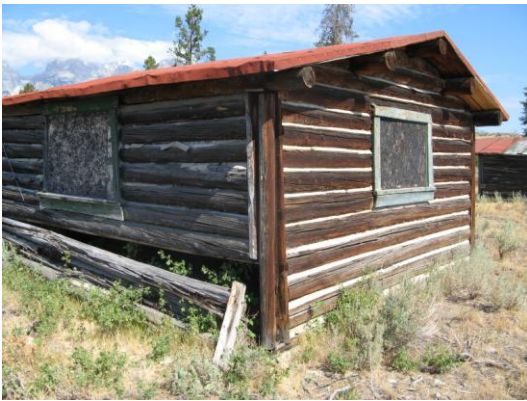
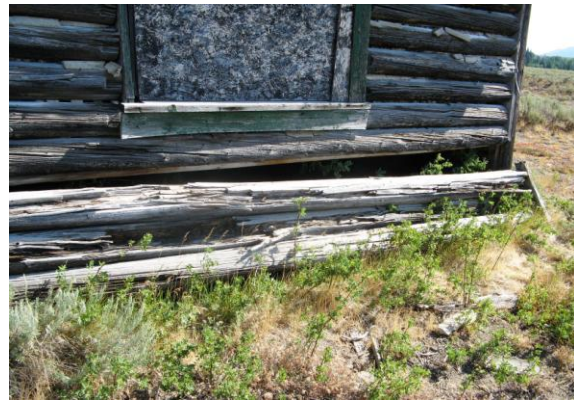
The Office Cabin (HS-1377) served as the office and mailroom for the guests staying at the Bar BC Ranch. This building also served as the tool and supply shed for our 2007 project. The East half of the South side of the Office Cabin had three logs roll out from the building leaving the cabin open to the weather and animals. The roll out of the three logs was caused from a collapse of the underlying rock supports, a rotting sill log and a rotted corner post at the SE corner. To stabilize the problem before further damage occurred it was decided to replace three bottom logs, the corner post and the supporting rock. New logs were hand peeled on site, the corner log and rock came from onsite.

**HS-1377 roll out of 3 logs**

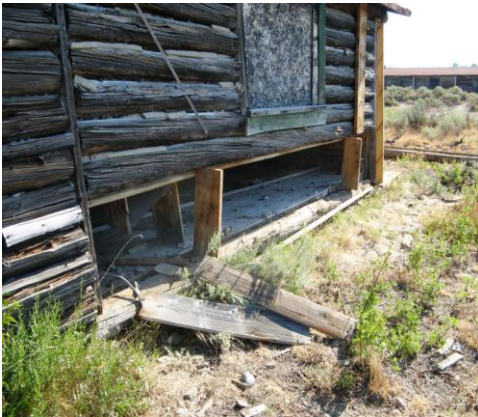
**HS-1377 3 logs removed and wall braced**

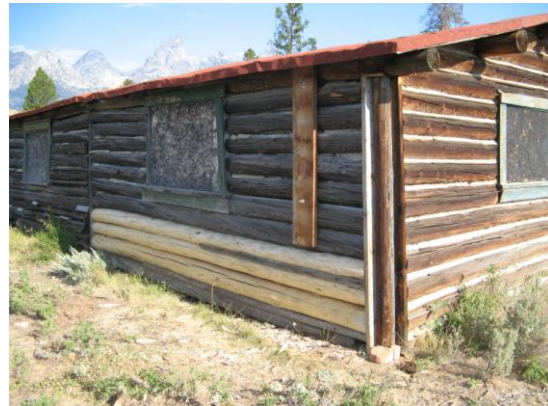
**HS-1377 new logs, corner post and support rock**

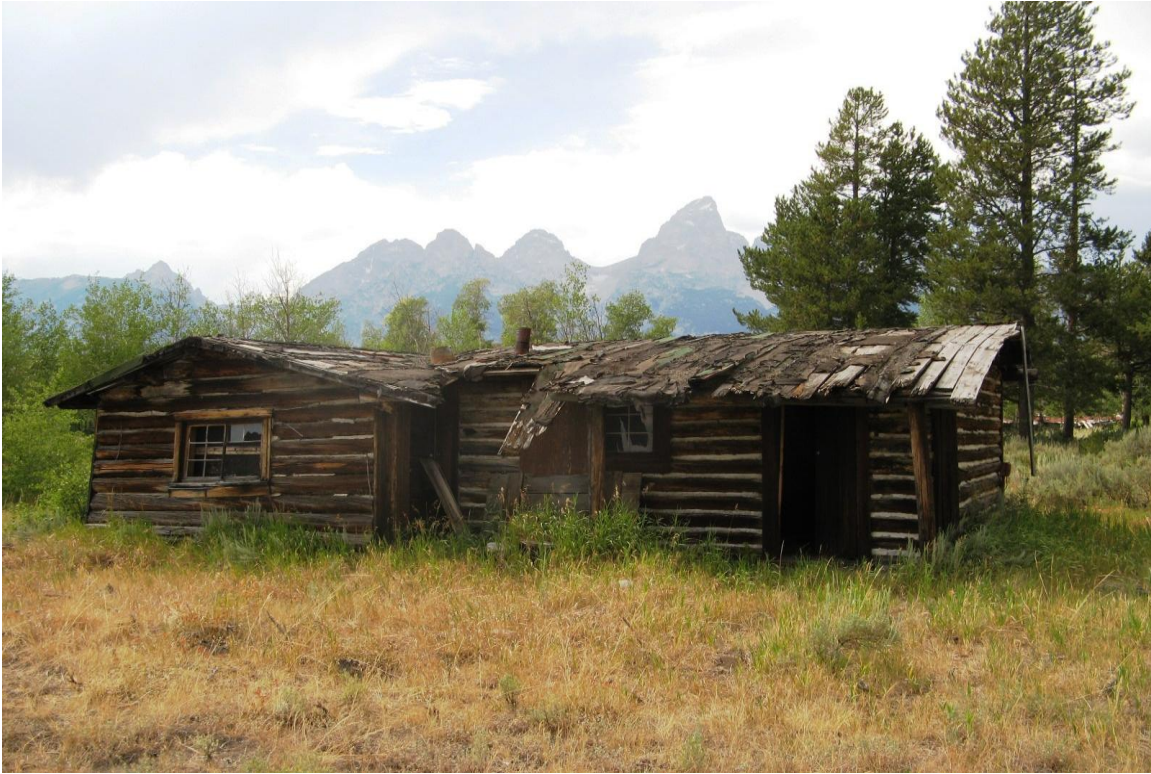
The historic dude cabin (HS-1382) is in poor condition. Needing to protect the cabins support infrastructure from further deterioration it was decided to tarp the roof as was done on the Main Cabin. The same procedures were used on HS-1382 as on HS-1366.

**HS-1382 before roof was tarped**

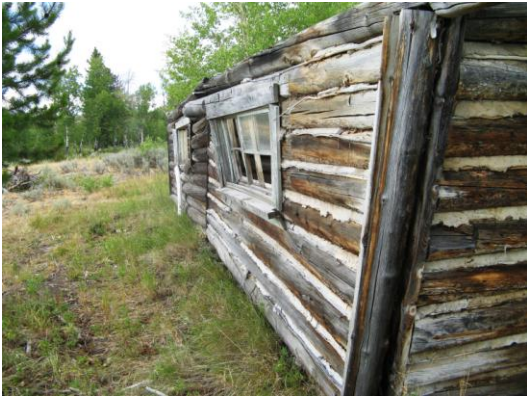
**HS-1386 Corner Post and Hog Trough**

The cabin style was hog trough with no log notching at the corners. To dismantle the wall sections the nails at the corners and interior wall location were cut from the attached 2" X 10" and 2" X 8" vertical wall and corner ties. The cabin was constructed using 6 separate wall sections and 1 interior wall section. These sections were sandwiched using 2" X 8" vertical boards positioned interior and exterior vertically across from each other.

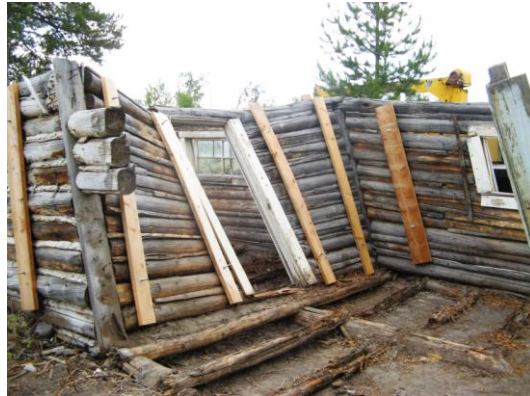
**HS-1386 Sandwiching Wall Together  
Also Floor Stingers Resting On Dirt**

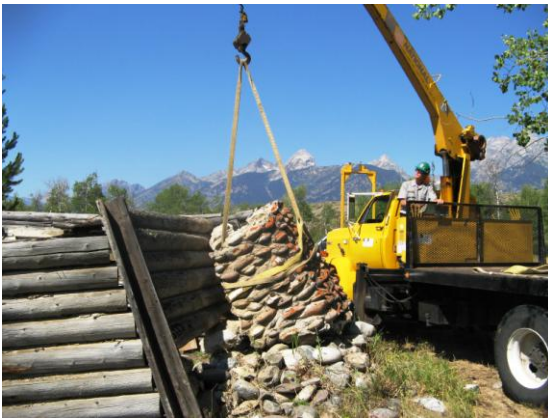
**HS-1386 Moving Chimney off North Wall**

To move the walls once they were sandwiched and separated at the vertical ties, straps were attached to each section and lifted with a crane. They were set far enough away to allow access to the building site for the pier footers and stem walls to be formed and poured with rebar reinforced cement. The crane was also used to move the intact portion of the chimney off the North wall to allow for its removal.

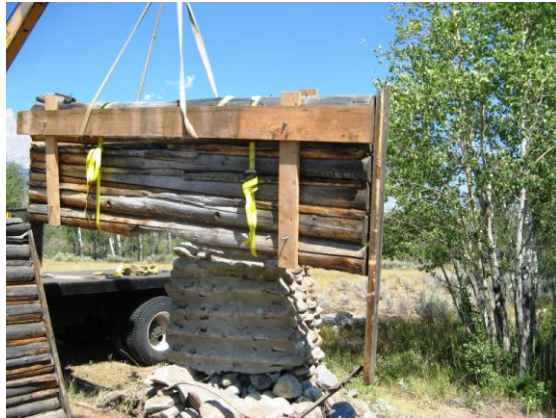
**HS-1386 Moving North Wall**

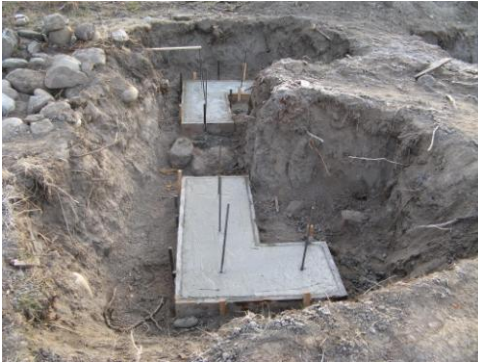
**HS-1386 Typical end footer**

Once the walls were set aside batter boards were placed for string lines to mark each side and corner of the original cabin. A level transit was used to set elevation on the batter boards. The string lines were adjusted to match the cabin dimensions and square. The location of each corner pier and the two piers where the sidewalls and interior wall attached were located and excavated to a depth of 42" (frost depth) with a backhoe. The forms for the pier footers were built to the proper dimensions and placed in the proper excavated hole. The forms were aligned plumb off of the string lines and set to elevation by means of the transit level. When the forms were plumb and level rebar was placed in the forms for reinforcement and they were poured with cement. While the cement in the footers was curing the forms for the stem walls were built and then installed on top of the

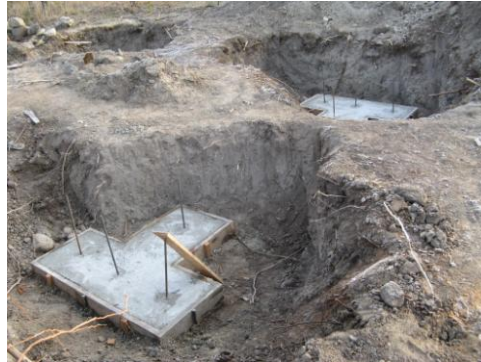
**HS-1386 Typical Center Footer**

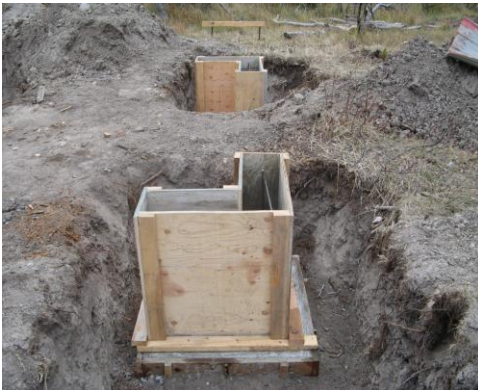
**HS-1386 Typical End Stem Wall**

footers. These were also aligned, leveled and set to the correct elevation. Rebar was also used in the stem wall forms as reinforcement before pouring with cement. The stem wall forms had block outs to provide for a floor joist ledger on the finished pier. Footers and foundation pier walls were placed to provide the needed support for the replacement of the historic sod roof, winter snow load, floor joist support and prevention of reoccurrence of cabin collapse. The chimney will have a steel reinforced pad placed under it to support the weight of the rubble style construction and rebuilt to original dimensions.

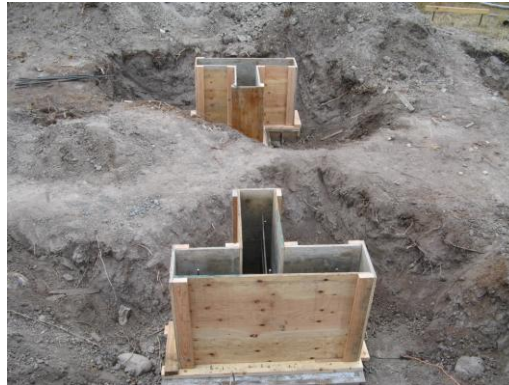
**HS-1386 Typical Center Stem Wall**

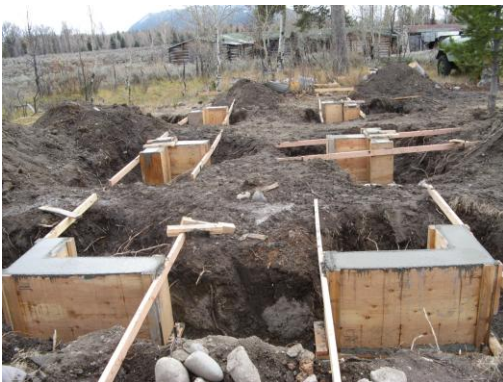
**HS-1386 Poured Stem Wall Forms**

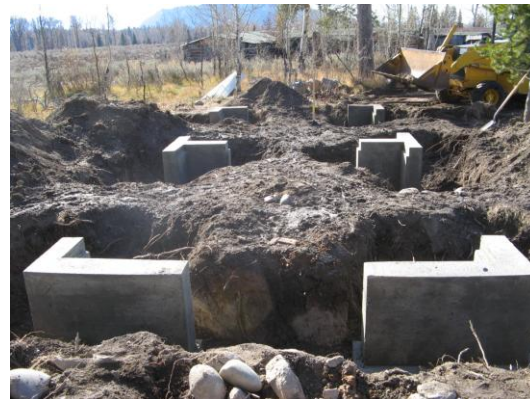
**HS-1386 Forms Removed**

The stem wall forms were removed and after curing all excavation was backfilled. The hog trough 2 X material and the wall sections along with the logs were restacked on blocks to keep them off the ground. The area was cleaned up and tools, supplies and materials stored for the winter.

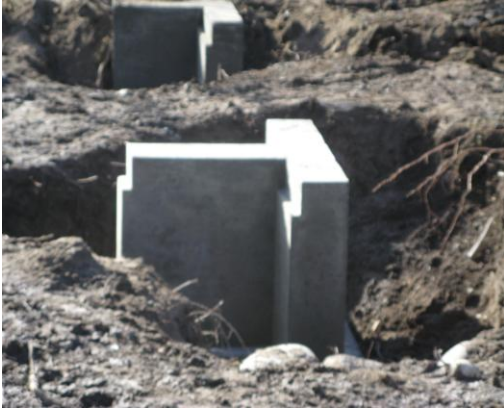
**HS-1386 Pier With Floor Joist Ledger**

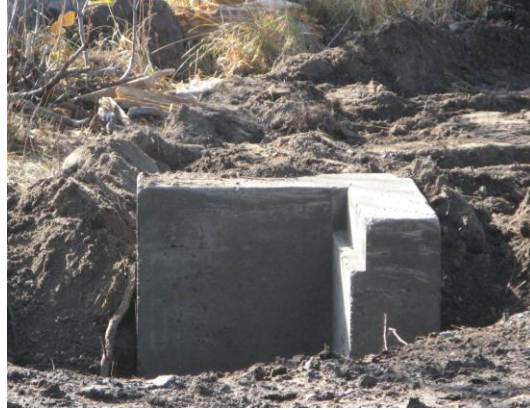
**HS-1386 End Pier With Floor Joist Ledger**

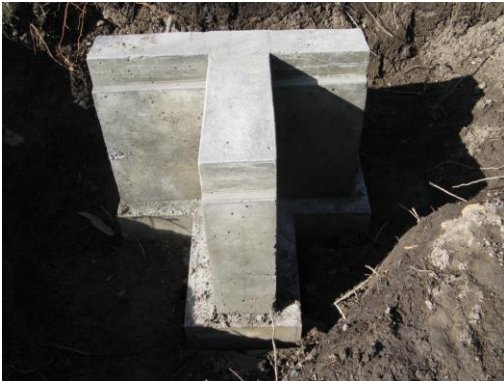
**HS-1386 Center Pier**

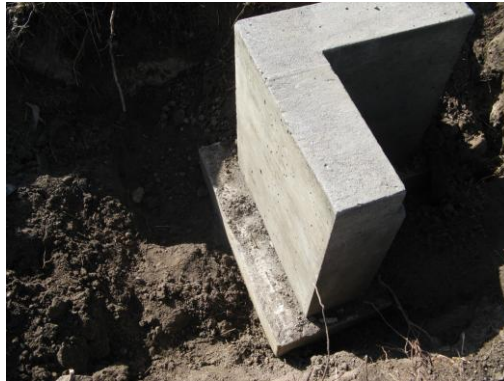
**HS-1386 End Pier**

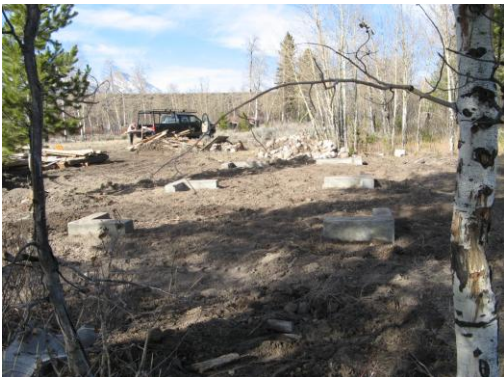
**HS-1386 Piers Backfilled**

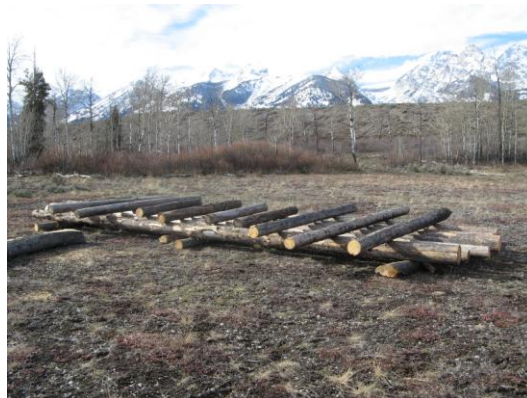
**HS-1386 Logs Stacked**

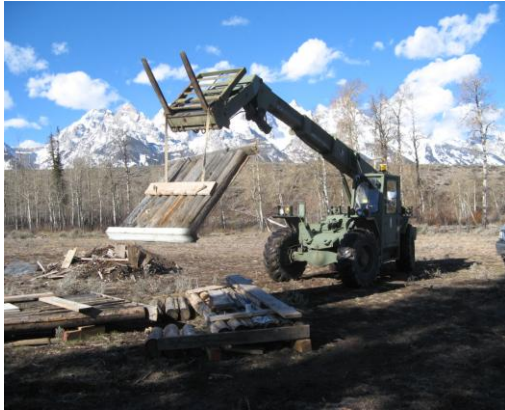
**HS-1386 Restacking Wall Sections**

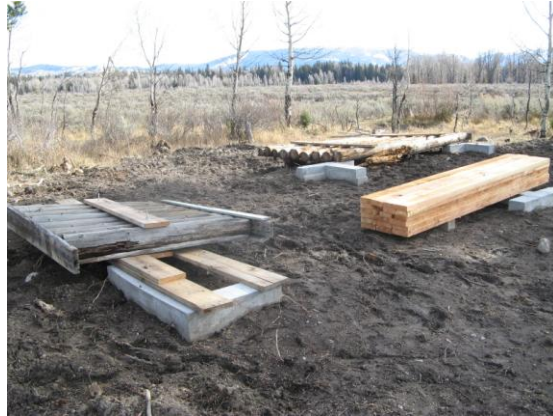
**HS-1386 Material and Wall Sections**
